THE ONTARIO POWER COMPANY OF NIAGARA FALLS

REPORT

ACCIDENT ON APRIL 20th, 1922

WALTER J. FRANCIS, C. E.

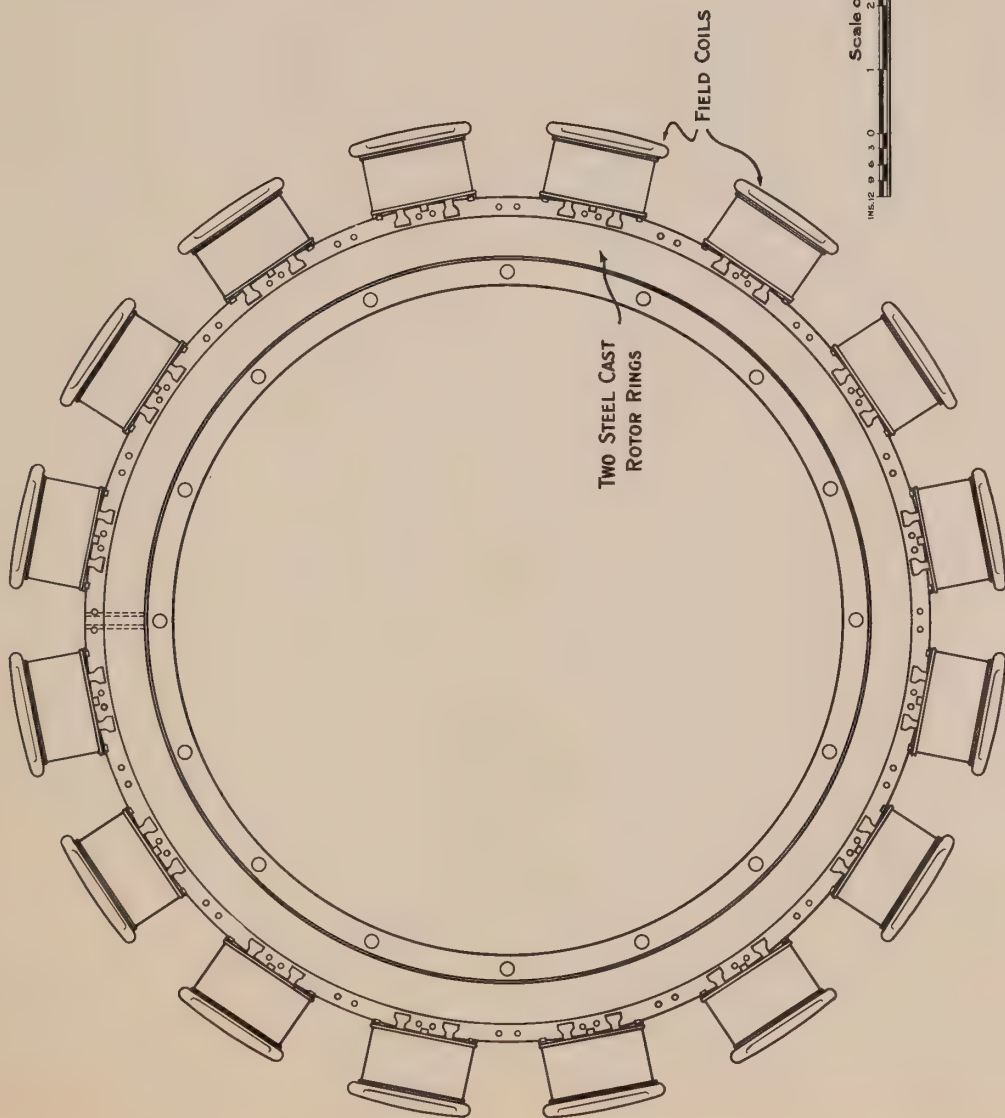
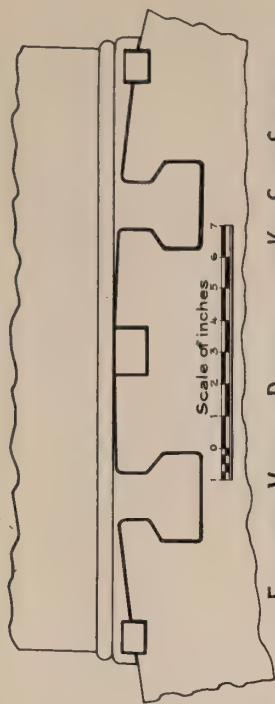
SIDE ELEVATION OF ROTOR RINGS
WITH FIELD COILS IN PLACE

ENLARGED VIEW OF DOVETAILS AND KEY SLOTS SHOWING
METHOD OF ATTACHING FIELD COILS TO ROTOR RINGS

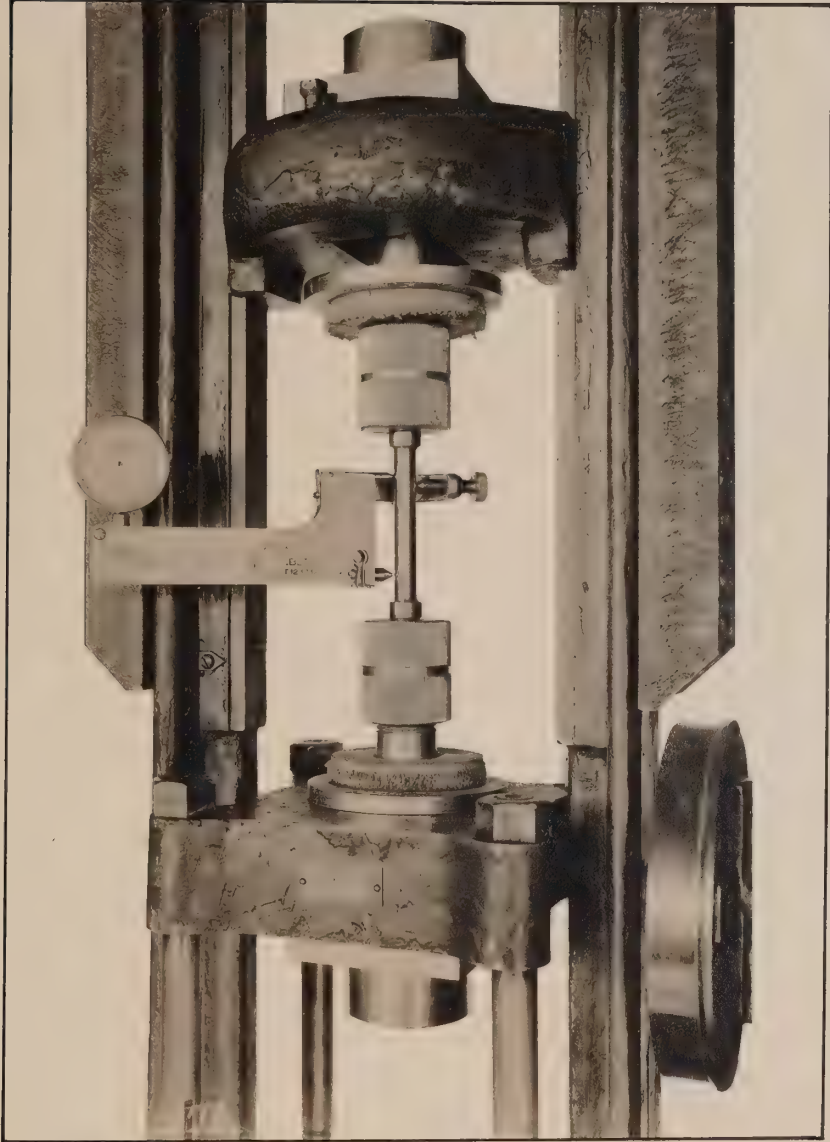
Method of Mounting Specimen in Testing Machine

The following are the results of the tests on the eight specimens of ring No. 11, as cut from the fragment without heat treatment:-

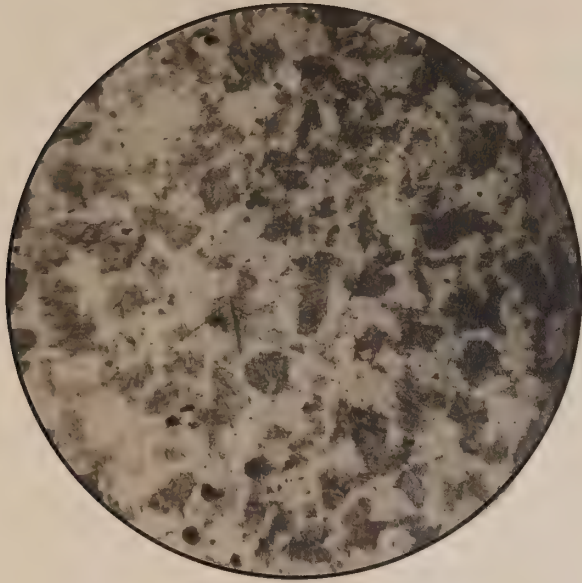
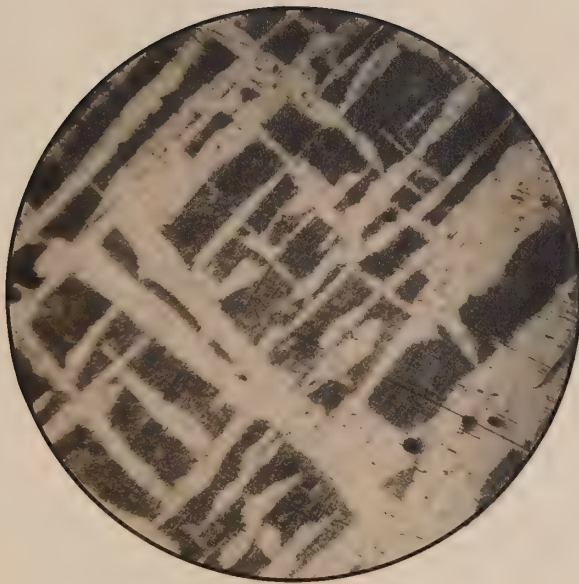
Before Annealing

In view of the fact that the stresses in such an element are always calculated for a uniform distribution over the whole cross sectional area of the element, it will be readily seen that absence of uniformity in the metal may be a serious matter.

The tests on the thirty-two specimens confirm the general finding in every instance, piece by piece and ring by ring, especially in regard to the percentage of elongation and the percentage of reduction in area, the two factors which indicate the ductility of the metal. It will be observed that even these factors vary between very wide limits, not only in the untreated specimens, but also in those cut from the annealed metal. It is doubtless beyond the scope of my instructions to do more than point out a very interesting divergence in the figures regarding reduction in area on the left hand side of the cross section of both of the rings as compared with the right hand on the drawing included herewith as page 41. In every case the ultimate strength and the elastic limit was materially improved by the heat treatment. This drawing is self explanatory, and would appear to indicate a result due to a definite foundry practice regarding the details of which I am unaware. As already stated, each of the rings in the rough weighed over twenty-two tons, and it will be seen that it was necessary to handle a very large amount of molten metal in making the castings.
